Athlone to Westport and Ballina.

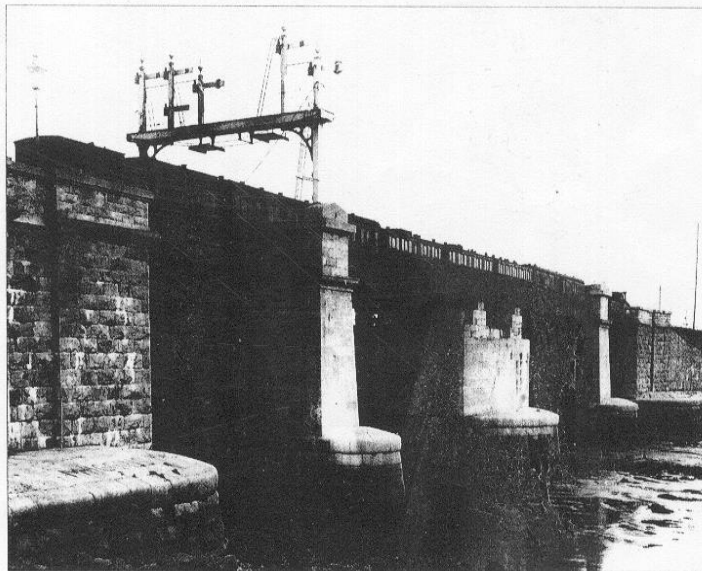
Lough Atalia Bridge was perhaps unique in that, whilst it included an opening span as built, it is believed to only have been opened once in connection with the Board of Trade inspection before the line was opened. Prior to its construction, local interests had vigorously campaigned for an opening span. This undated photograph was probably taken in the closing years of the nineteenth century. Author's collection.
